NRL Memorandum Report 4003

Shock Performance of a Shipboard Electrical Switchgear

EDWARD W. CLEMENTS

June 15, 1979

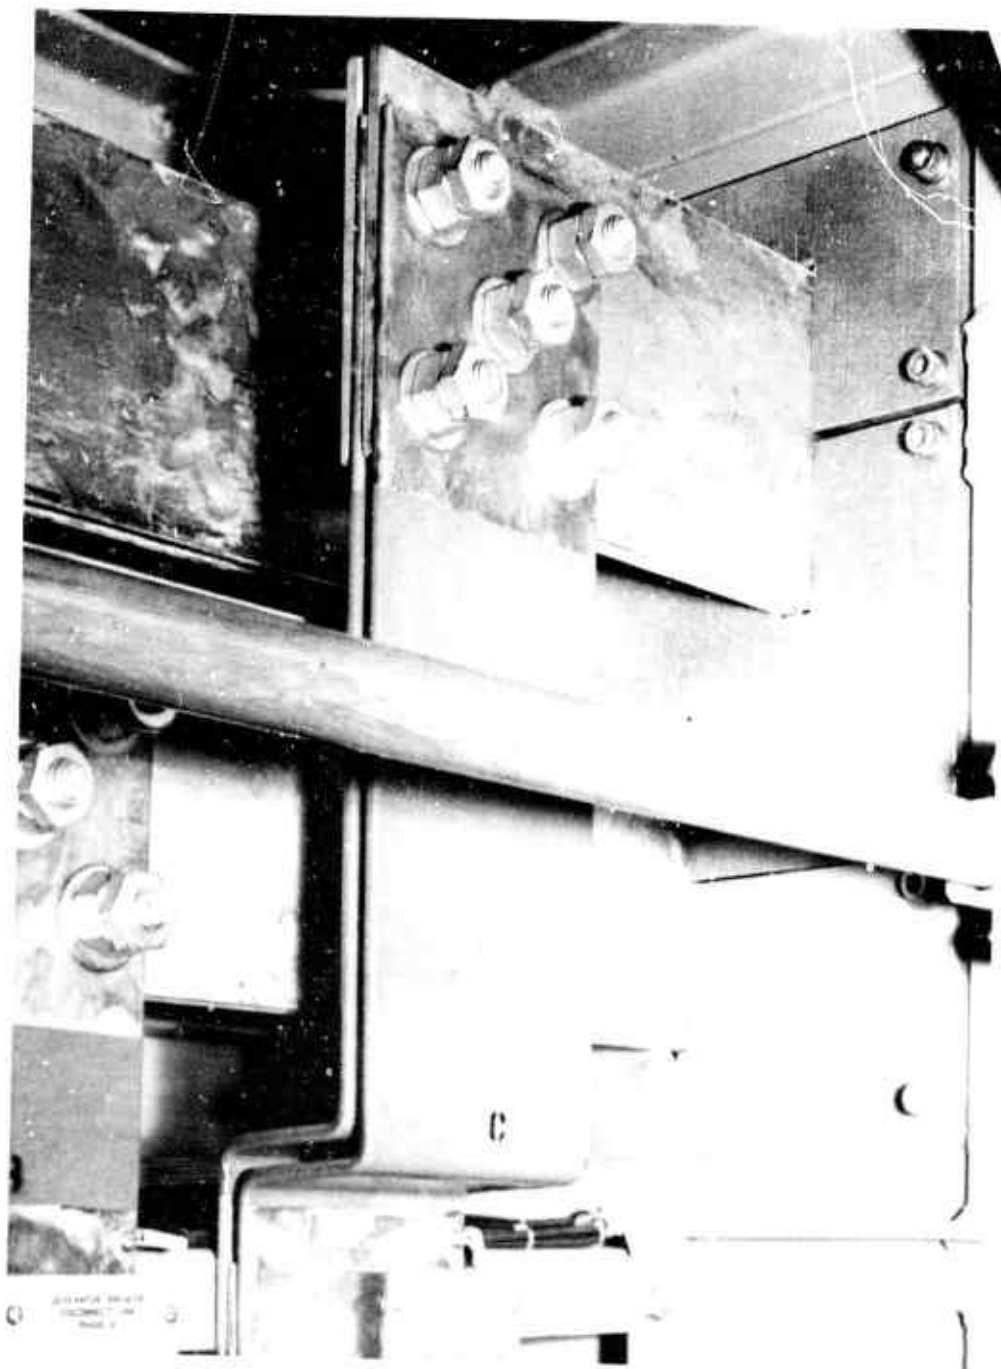
Fig. 54 - Damage from Shock Test - 2400 A Breaker Bay (Rea-).
Note cracking and abrasion of melamine support for main horizontal
bus between 2400 A and 1600 A Breaker Bays.

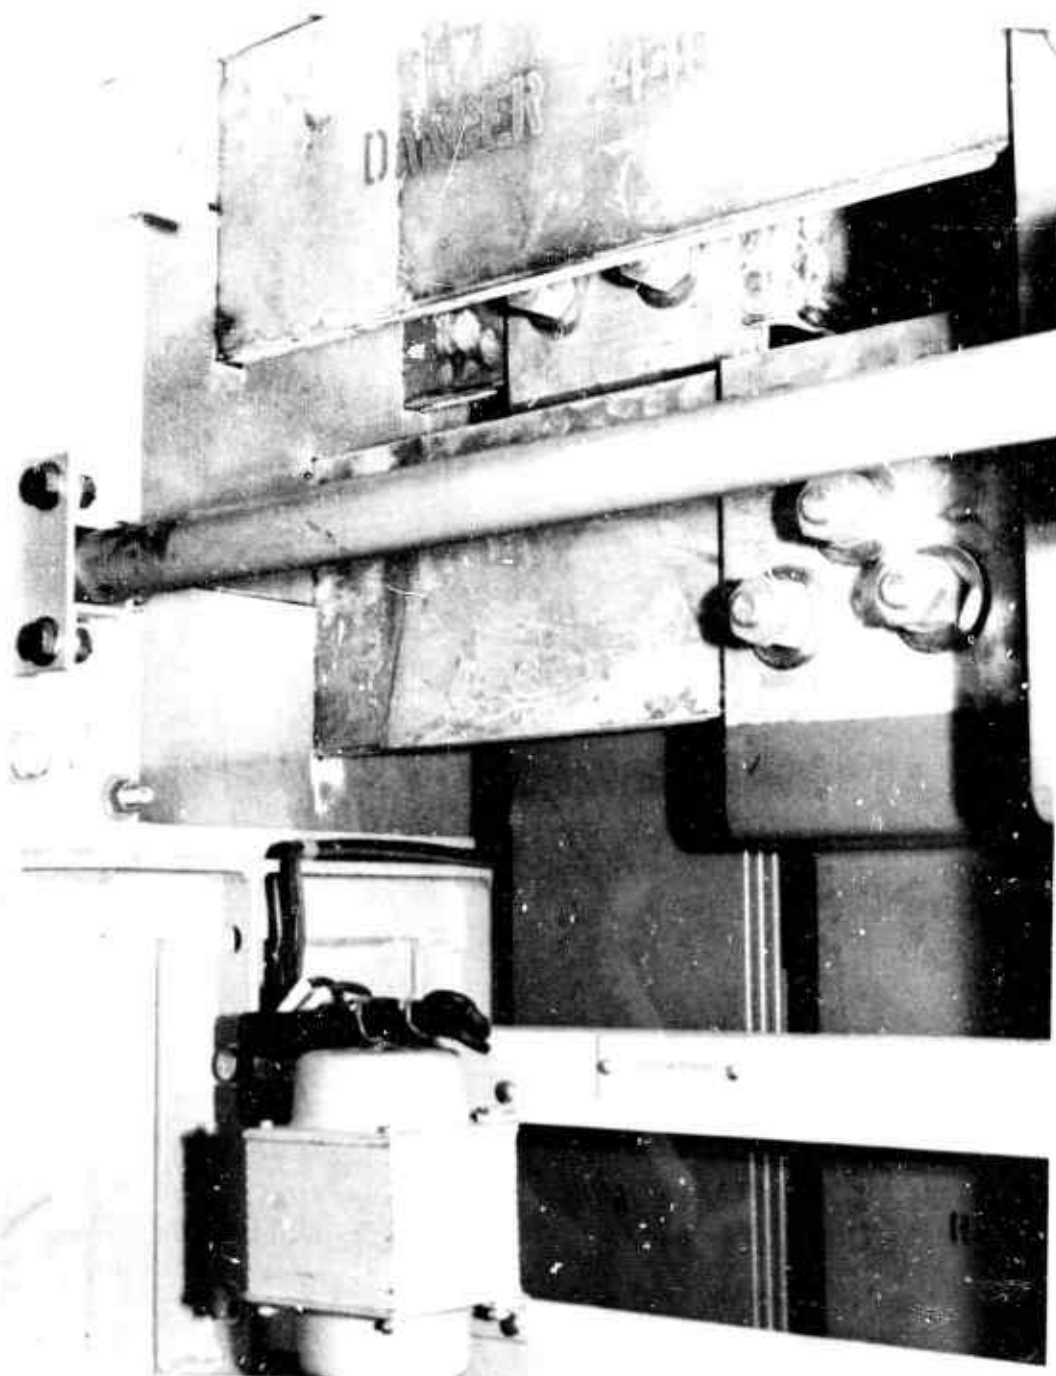
Fig. 55 - Damage from Shock Test - 1600 A Breaker Bay (Rear).
The same damage as Figure 48 from the 1600 A Breaker Bay side.

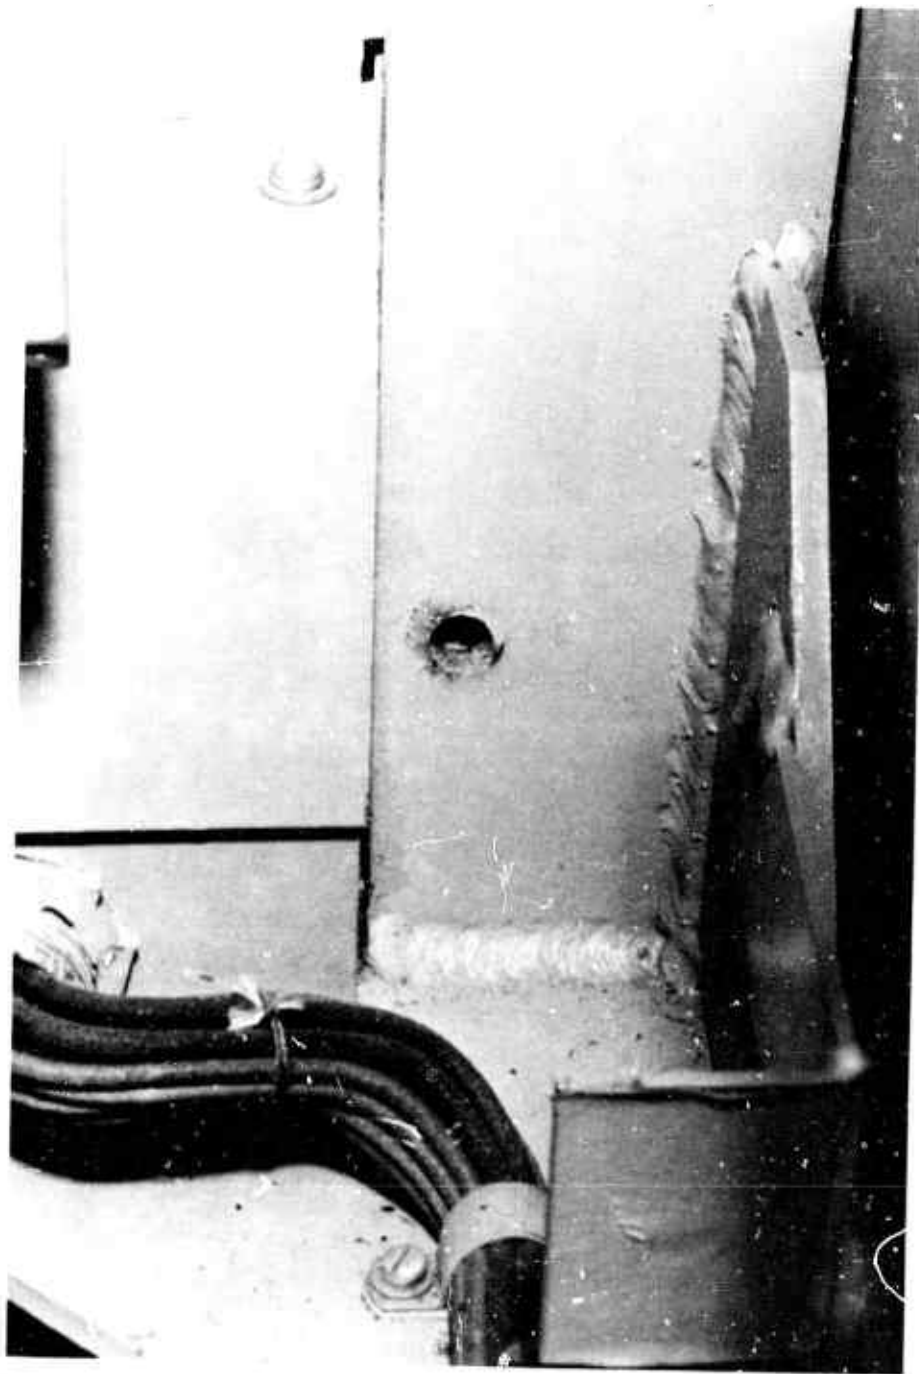
Fig. 58 - Damage from Shock Test - 1600 A Breaker Bay (Rear).
Sheared bolt supports lower base frame for the lower 1600 A
Breaker.

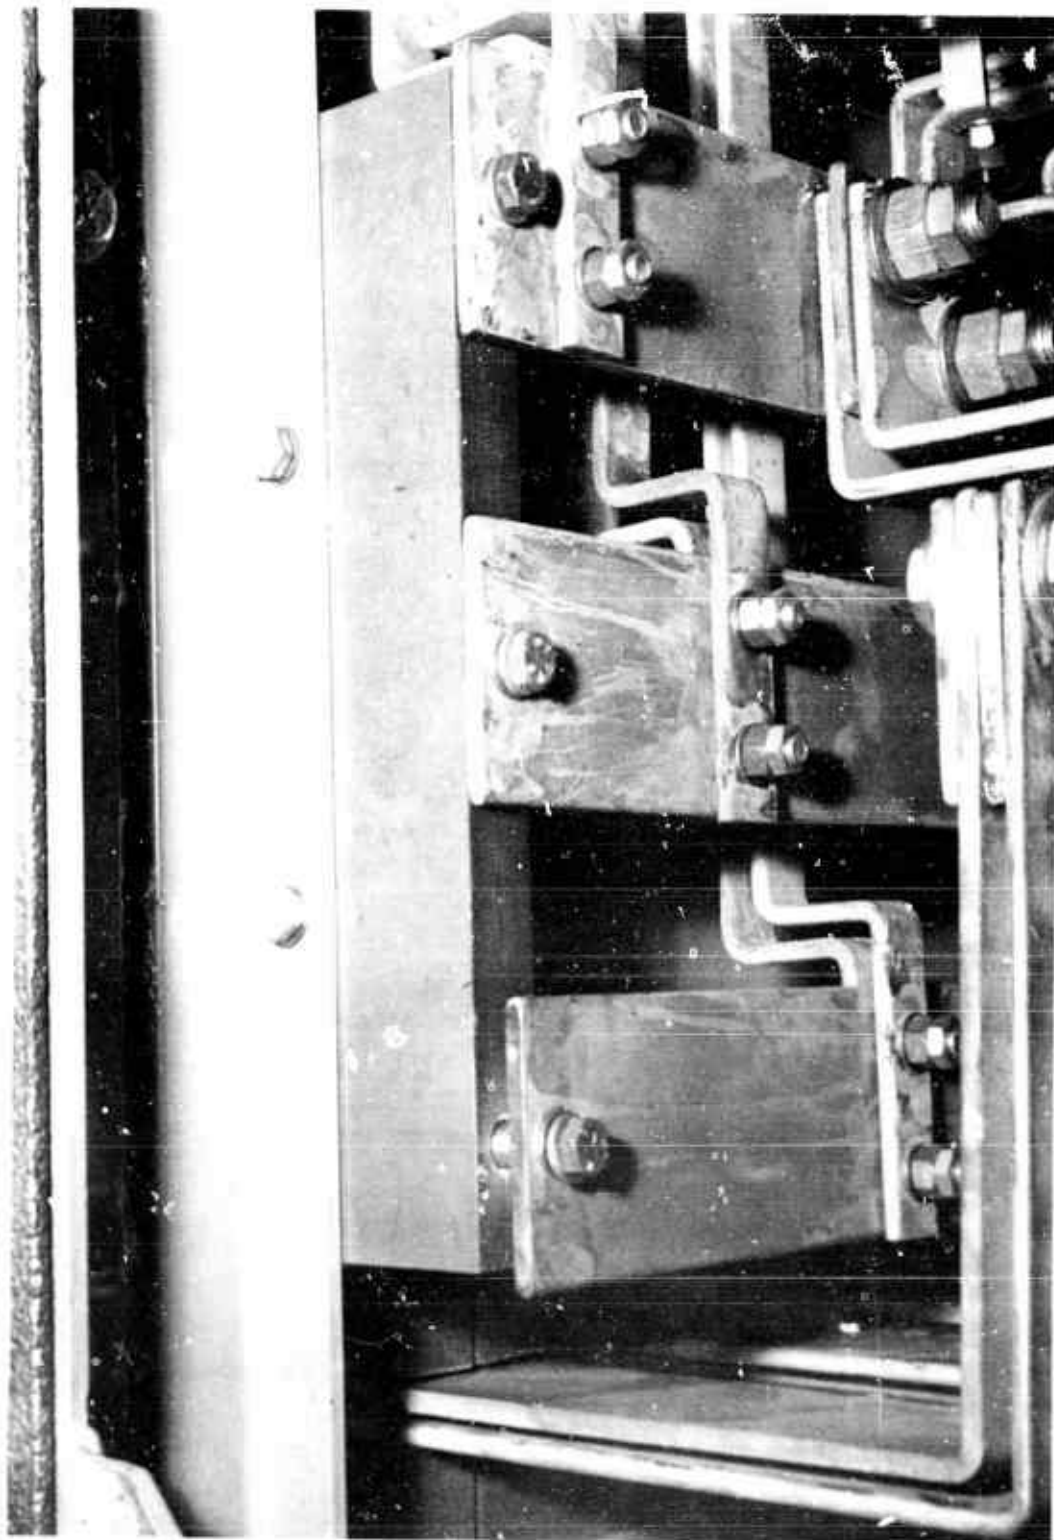
Fig. 59 - Damage from Shock Test - AQB Breaker Bay (Rear). Stripped helicoil in the melamine support at upper end of main vertical bus.

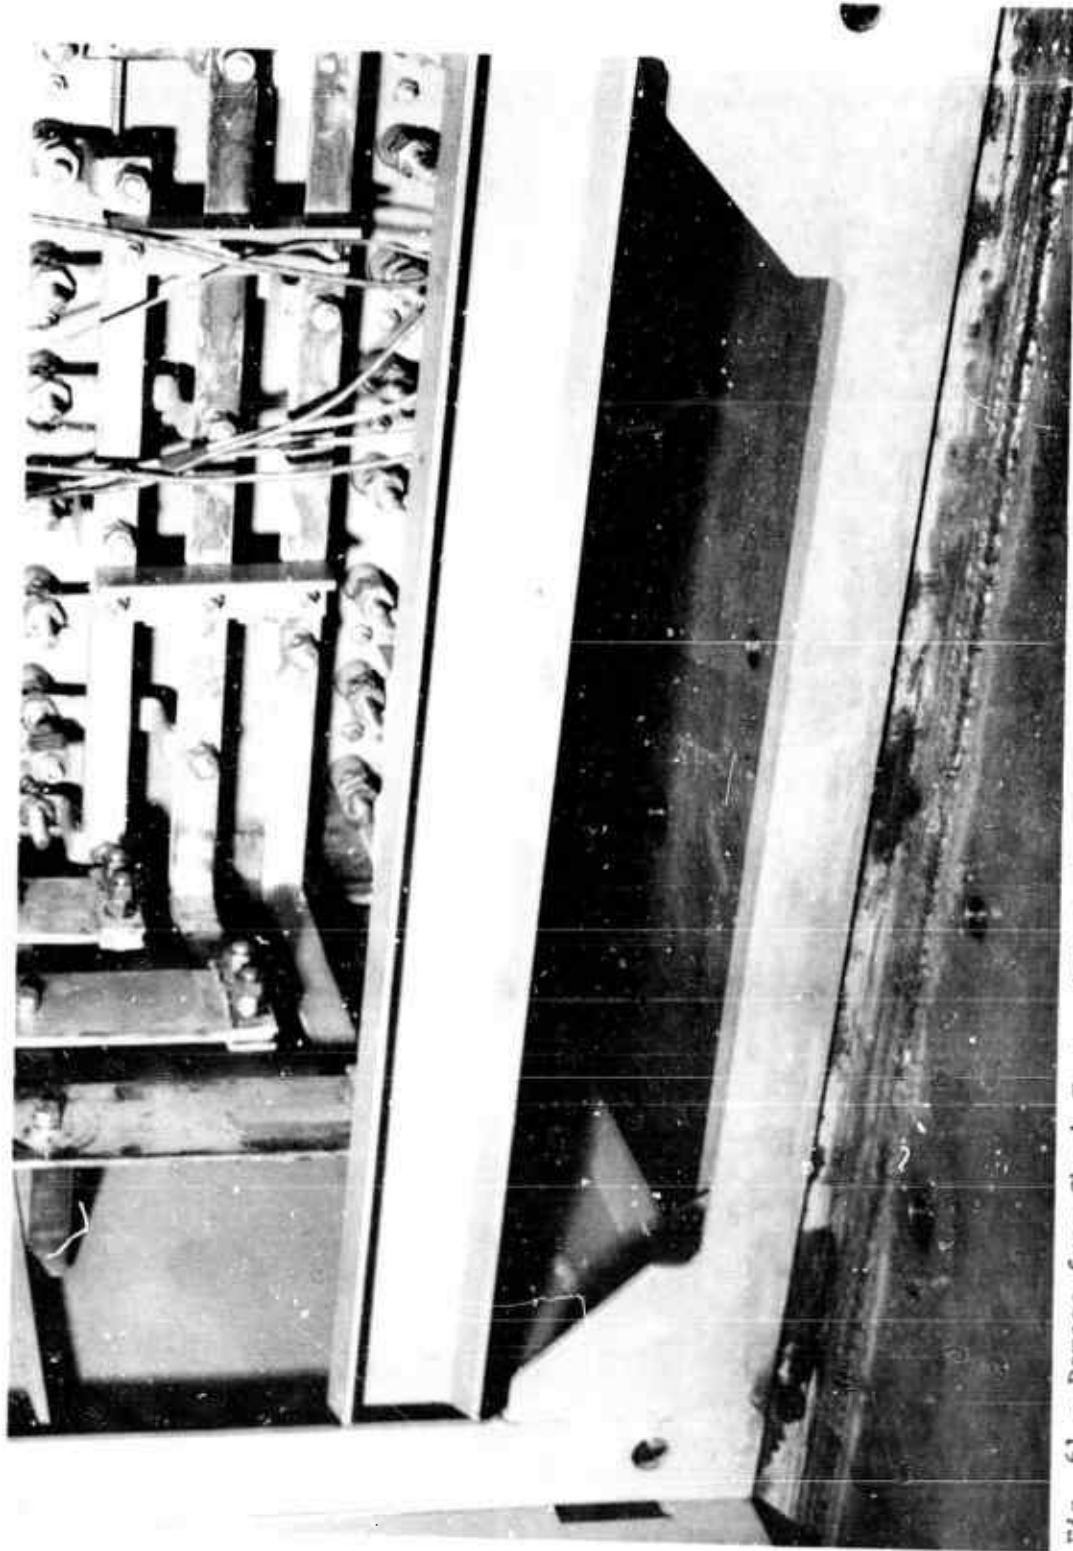
15. Welds of the gusset plates at the bottom rear of the AQB bay were broken (Fig. 61).

Fig. 61 - Damage from Shock Test - AQB Breaker Bay (Rear). Cracked welds in gussets at base of frame.

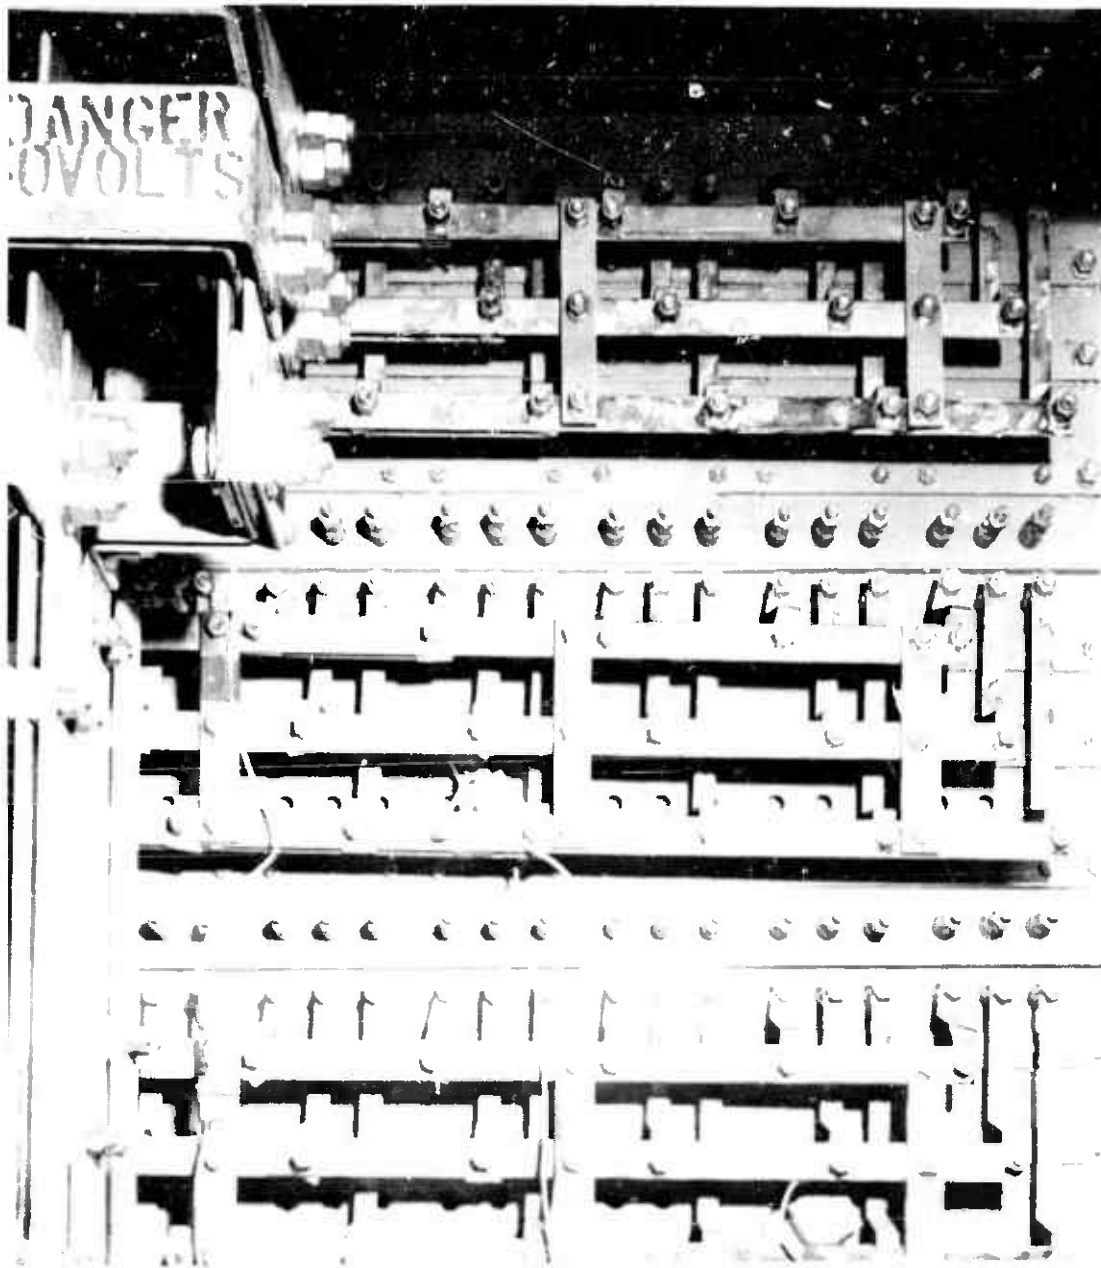
Fig. 62 - Damage from Shock Test - AQB Breaker Bay (Rear). Downward tilt of LF100 horizontal buses and deformation of breaker pickoffs.

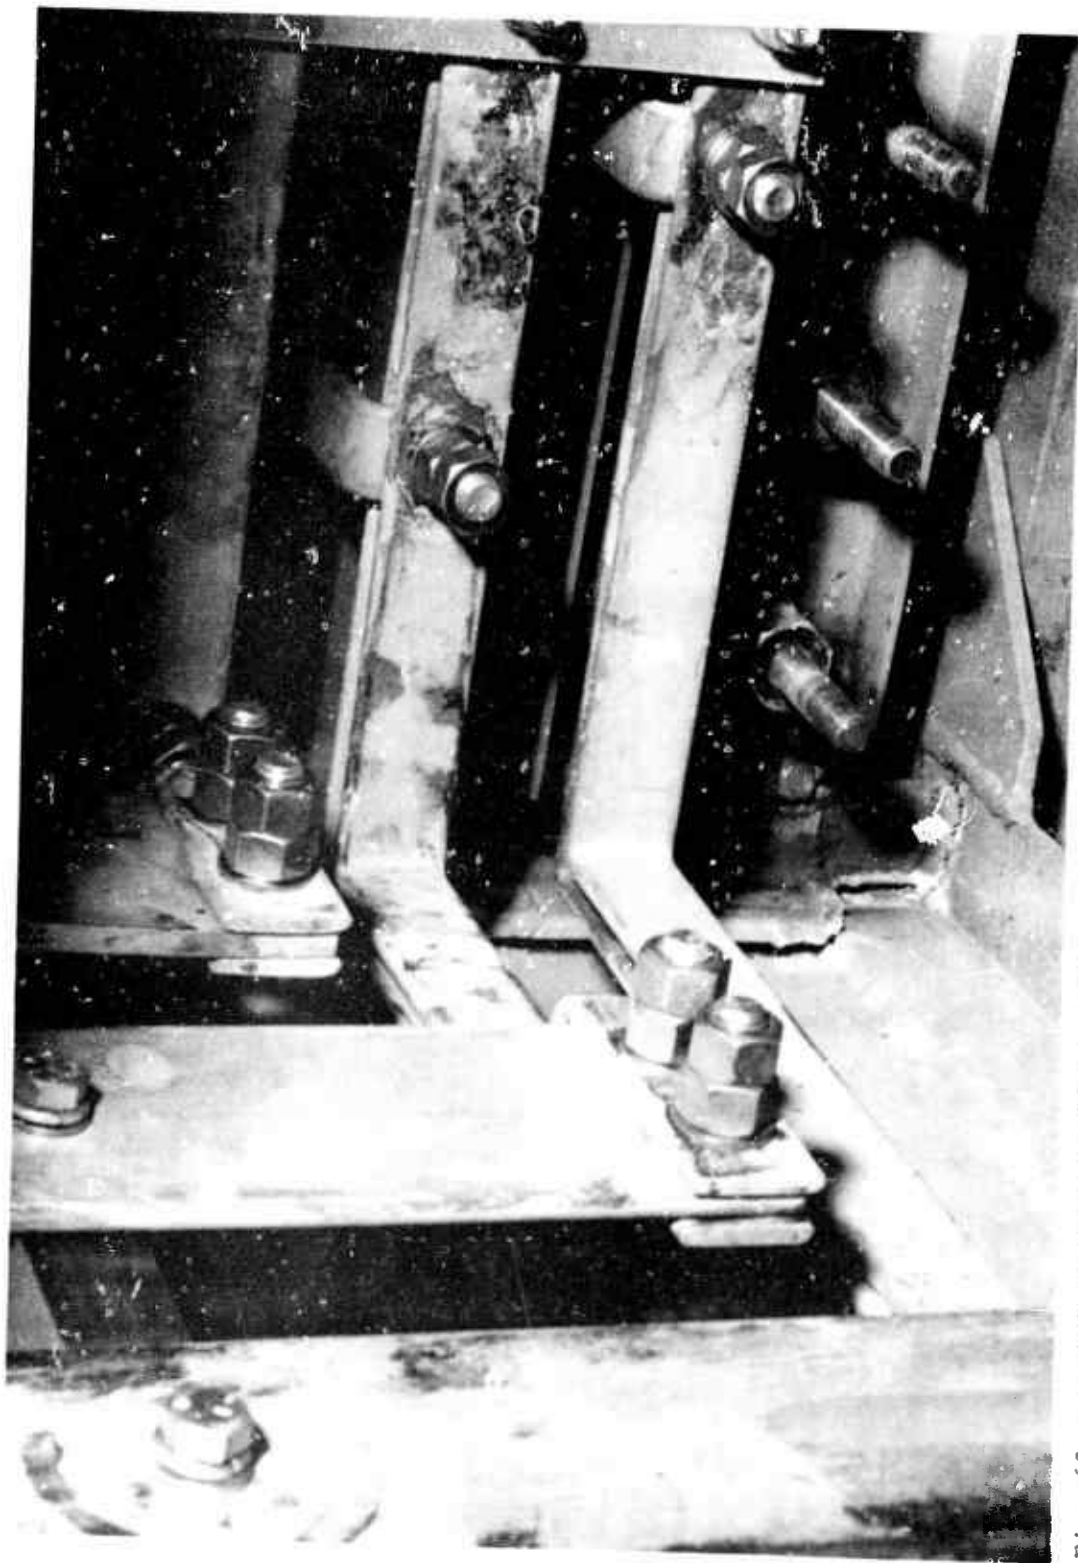
Fig. 63 - Damage from Shock Test - AQB Breaker Bay (Rear). Broken welds in frame base structure, inboard end.

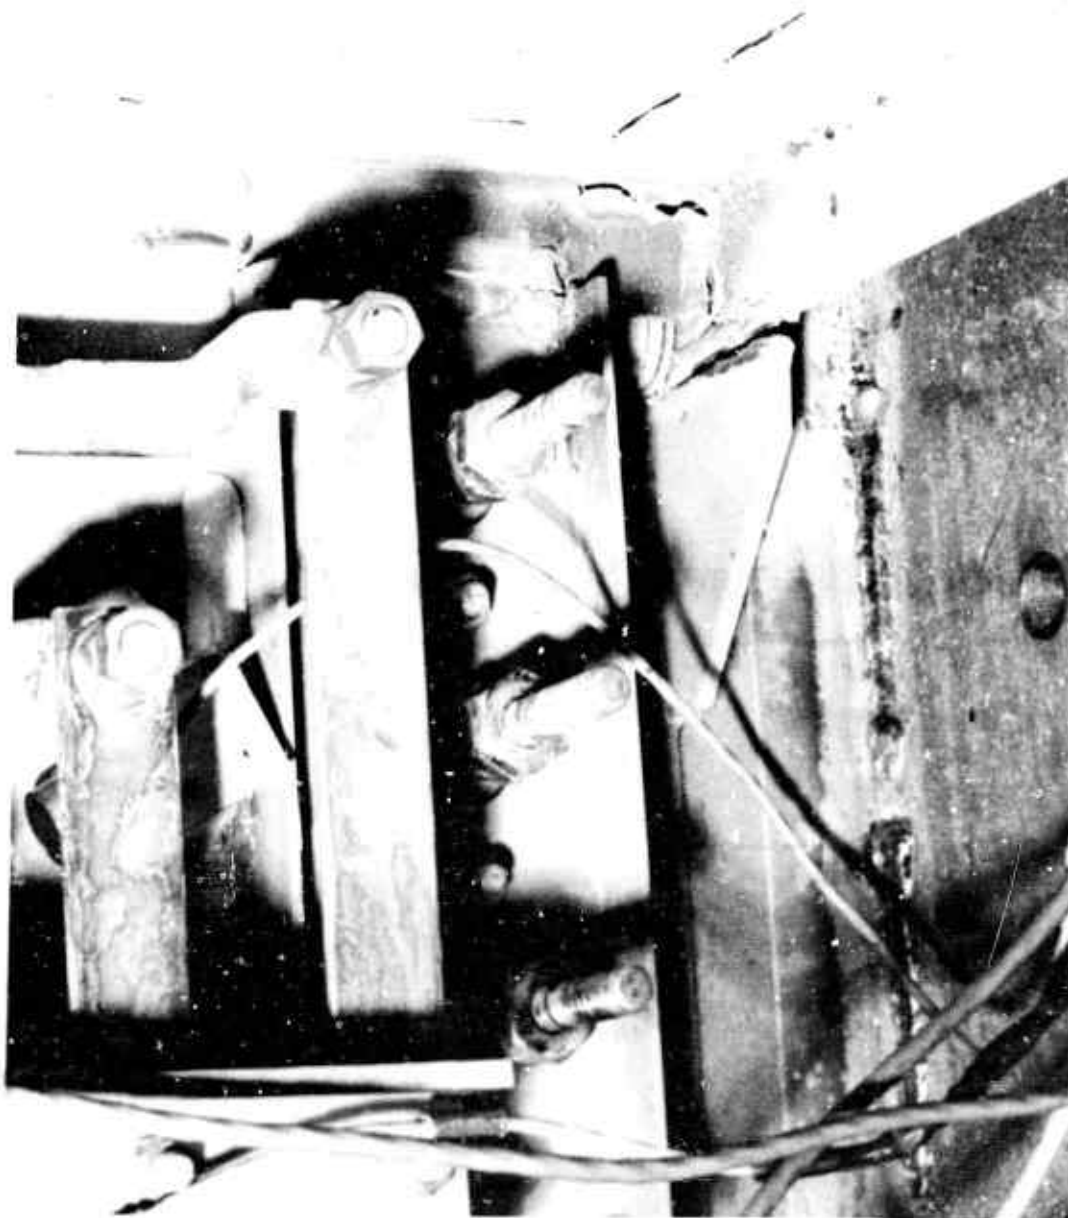
Fig. 64 - Damage from Shock Test - AQB Breaker Bay (Rear). Broken welds in frame base structure, outboard end.
